Location: Cypress Infants and Junior, Informal Crossing, Auckland Road, Upper Norwood, Croydon.

Project: School Crossing Patrol

Stage 1 Road Safety Audit

Date: July 2025

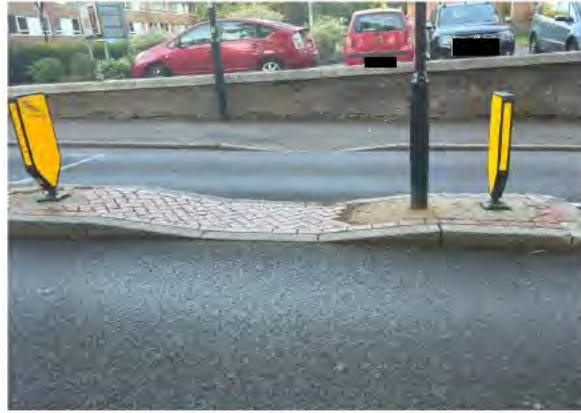
Photo 1: Existing dropped kerb

Details: During the site visit, it was observed that the existing crossing point only had 1m long drop kerb at the footway on both side and the refuge island.

Concern arise that 1m long drop kerb might not be able to accommodate the large number of pupils during the school drop off and pick up times, trip of fall type injuries. Furthermore, pupils might cross the carriageway at an unsafe location resulting in conflict with motorist.

Recommendation: It is recommended increased the length of drop kerb to minimum of 2m.

Highway Authority response: As part of the Council's ongoing commitment to improving pedestrian safety and accessibility, a raised zebra crossing has been installed at the junction of Auckland Road and Cypress Road (plan provided). This facility provides a formalised crossing point that meets the design and accessibility standards, thereby improving conditions for pedestrians travelling to and from the nearby school on Cypress Road.

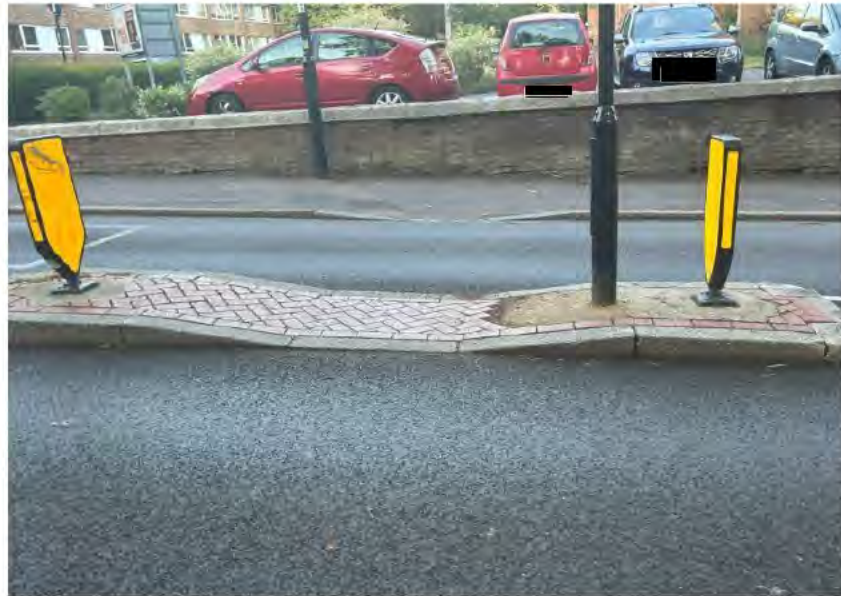
Photo 2: Existing Central Island

Details: During the site visit, it was observed that the central island at the crossing point is approximately 1m wide. With the route highlighted for parents crossing at the location there may be a need for pedestrians to wait within the central island.

The concern is that pedestrians with prams or pushchairs, or children with cycles will not be able to wait safely within the central island, which may lead to vehicles side swiping the waiting pedestrians at the location.

Recommendation: It is recommended that the central waiting area provides adequate space to allow pedestrians to safely wait at the location

Highway Authority response: As part of the Council's ongoing commitment to improving pedestrian safety and accessibility, a raised zebra crossing has been installed at the junction of Auckland Road and Cypress Road (plan provided). This facility provides a formalised crossing point that meets the design and accessibility standards, thereby improving conditions for pedestrians travelling to and from the nearby school on Cypress Road.

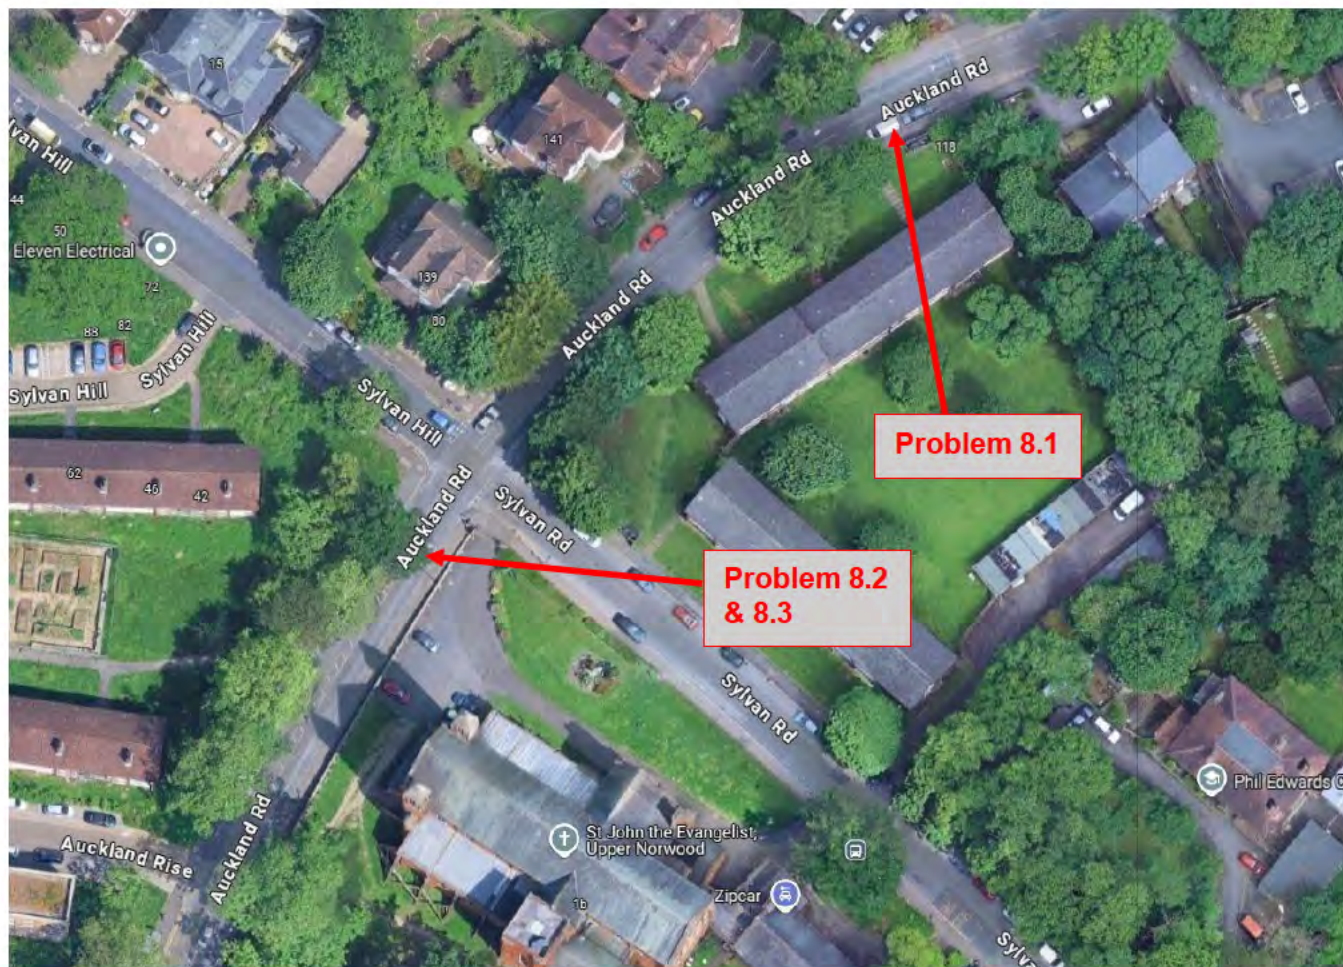
PROBLEM LOCATION PLAN

Existing centre island where
RSA was undertaken
