**Location: Monks Orchard Primary School
The Glade by No. 251**

Project: Removal of Crossing Patrols

Stage 1 Road Safety Audit

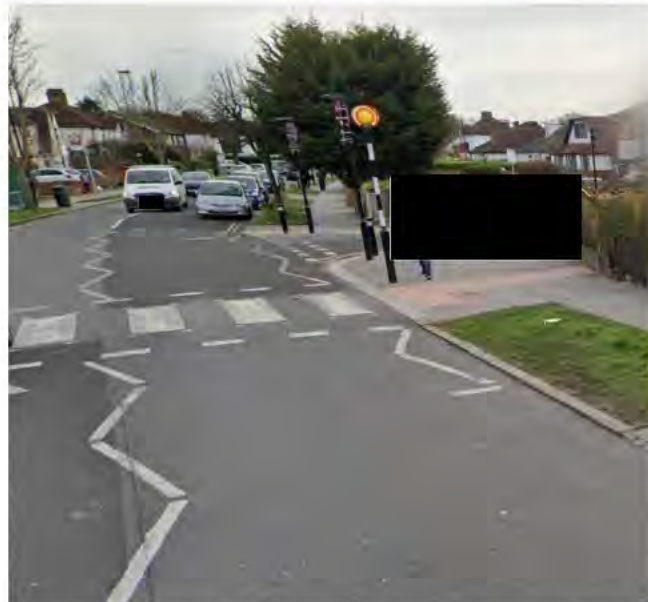
Figure 1: Zebra crossing outside 253 The Glade

Location: Central island for the zebra crossing

Summary: Risk of vehicles colliding with islands or pedestrian

Details: During the site visit, it was observed that the existing zig-zag markings at the exit of the zebra crossing are only two markings long, as shown in Photo 1 below. This limited length may reduce the visibility of pedestrians waiting on the opposite side of the carriageway, especially near the school, for approaching drivers.

The Audit Team has expressed concern that this limited visibility could lead to pedestrians entering the carriageway without providing sufficient warning to oncoming vehicles, thereby increasing the risk of potential conflicts at this location.

Recommendation: It is recommended the zig-zag markings are extended so to provide clear visibility to the approaching driver for any pedestrian waiting to cross at the location.
